SUBJECT: Report of Replacement Reserve Study  
9400 Condominium  
Ocean City, Maryland  
ETC Project: M5-5283

**APPENDIX A  
PHOTOGRAPHS  
9400 CONDOMINIUM  
OCEAN CITY, MARYLAND  
ETC PROJECT M5-5283**

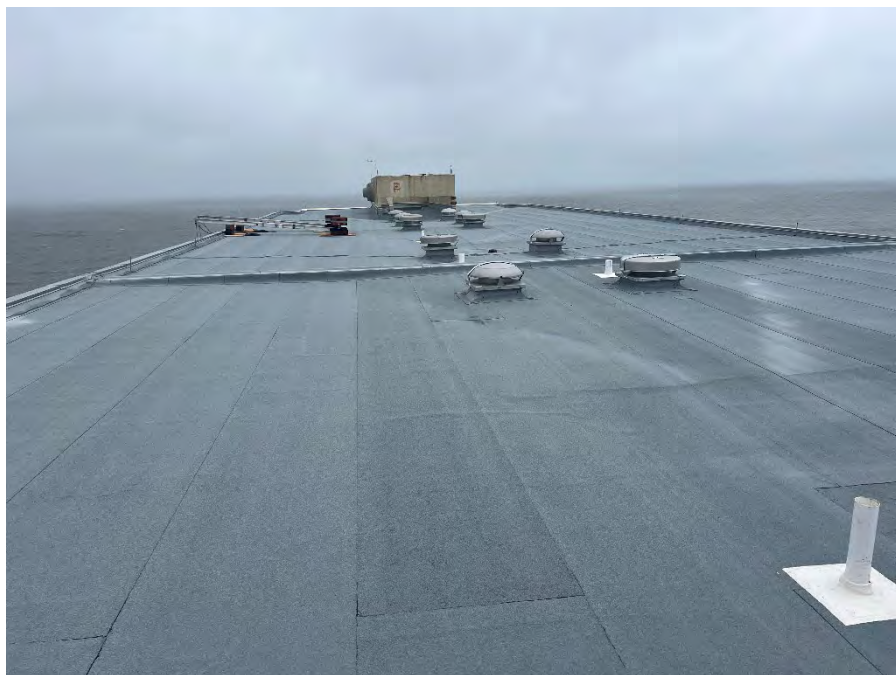
The roof coverings appeared to be in relatively good condition. No issues were noted during our inspection, nor were any reported to us.

Photograph 1 – Main roof.

In our opinion, general maintenance and repairs should be done on an as-needed basis to maximize the life expectancy of the roof systems. Drains should be cleaned periodically to maintain proper function.

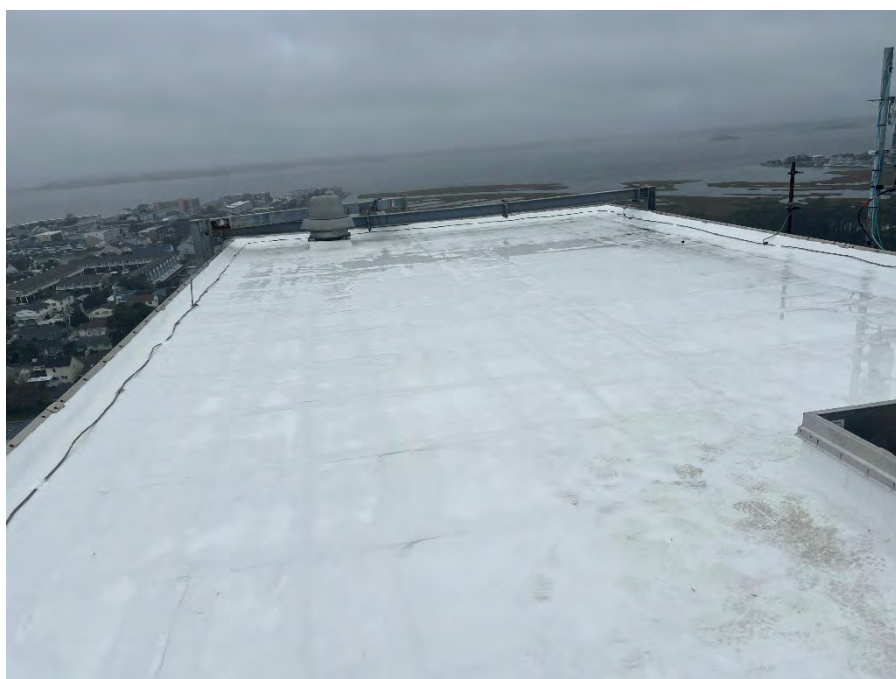
Photograph 2 – Penthouse roof.

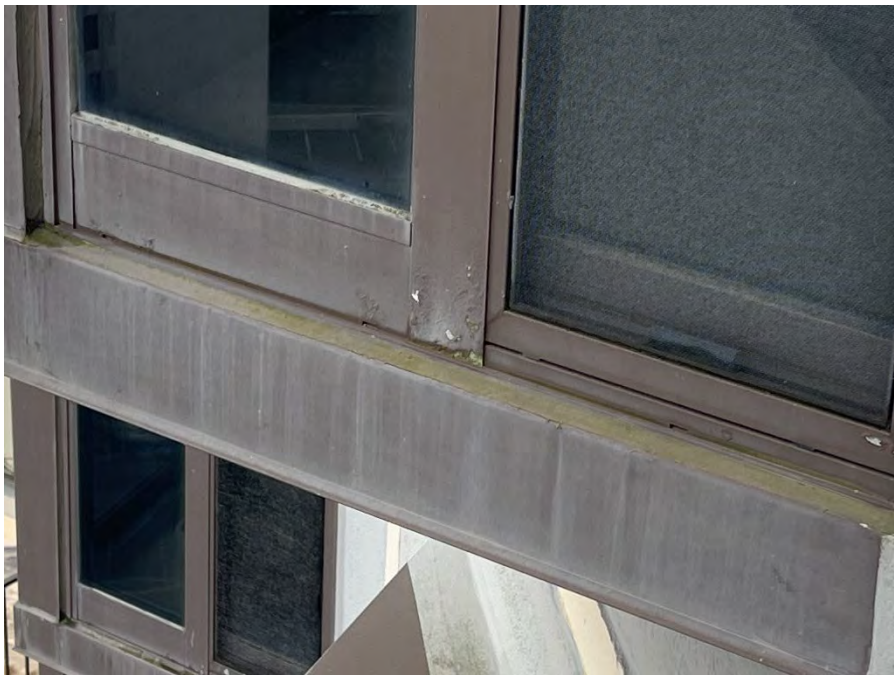
The windows and doors appeared to be in fair condition. The color-coat was debonded along the base of the windows in some areas (see Photograph 5). Additionally, the color coat on the window frames was faded in numerous instances (see Photograph 6). Corrosion (rust) was evident on several steel doors (see Photograph 7).

Photograph 5 – Debonded color-coat at base of window.

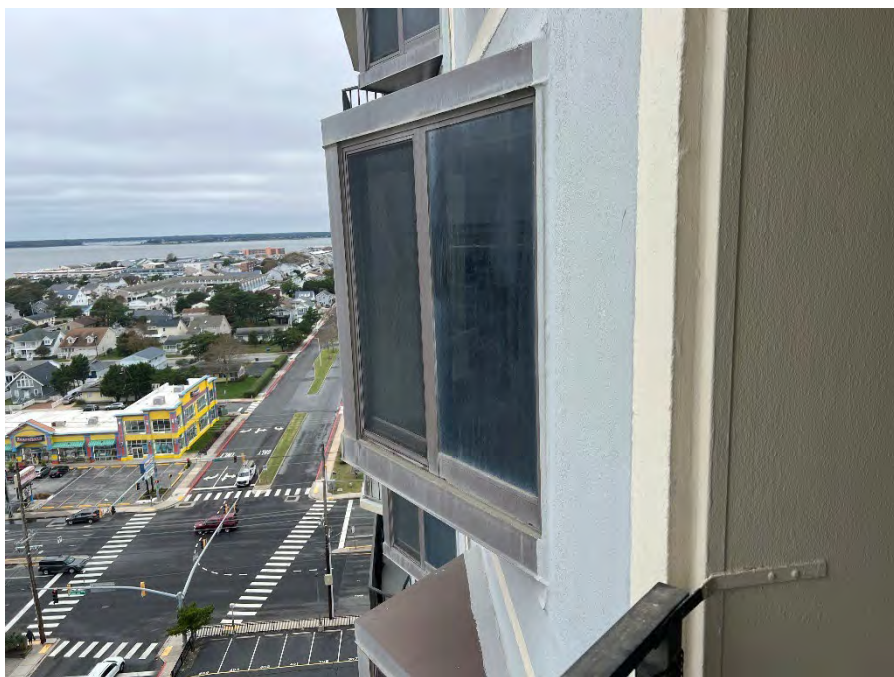
Photograph 6 – Faded color-coat on window.

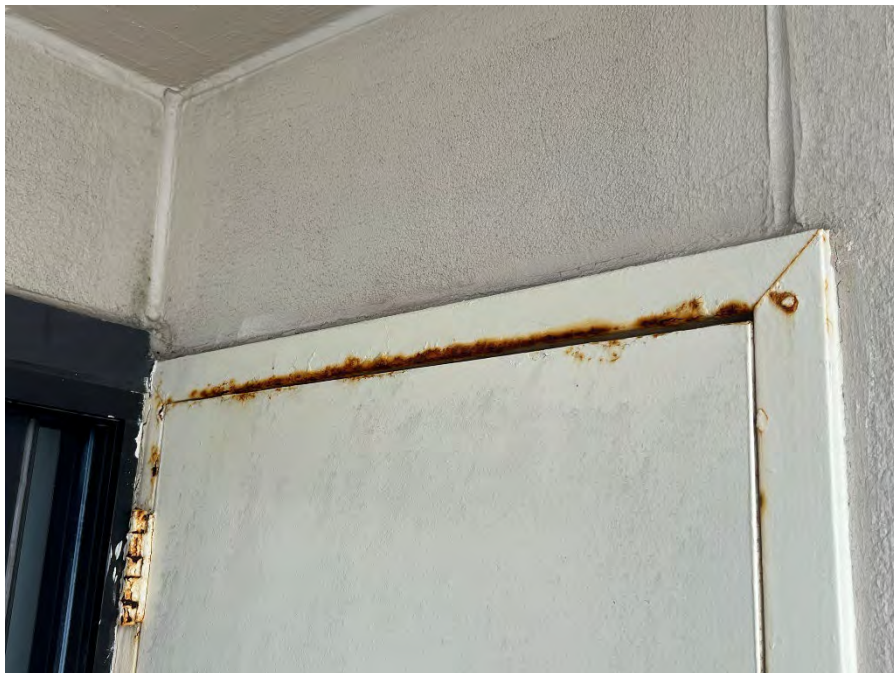
Photograph 7 – Corrosion on steel door

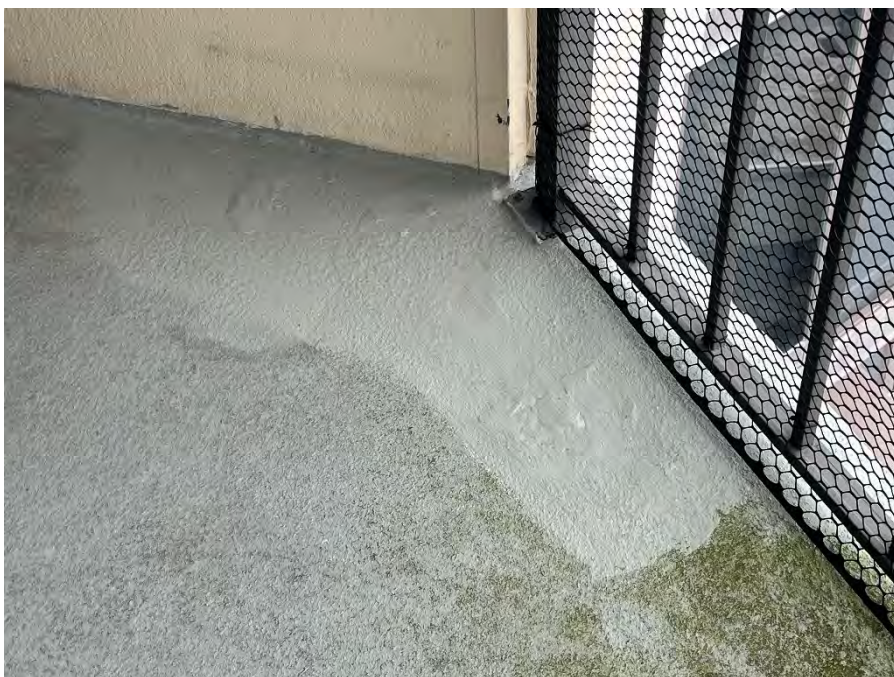
1. Several repairs were noted in the balcony coatings (see Photograph 8). The areas of new coating were typically visible due to the age of the existing coating.
2. Staining or vegetation growth was noted on a few of the balconies (see Photograph 9).

Photograph 8 – Balcony coating repair.

Consideration should be given to a full balcony restoration project, including concrete repairs, recoating, and replacement of railings with code-compliant railings.

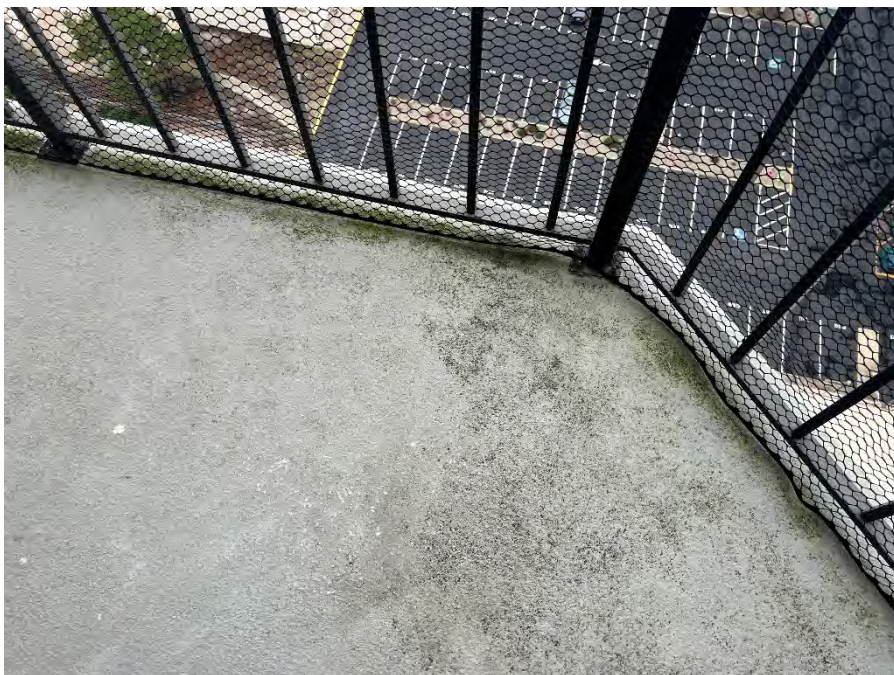
Photograph 9 – Staining on balcony.

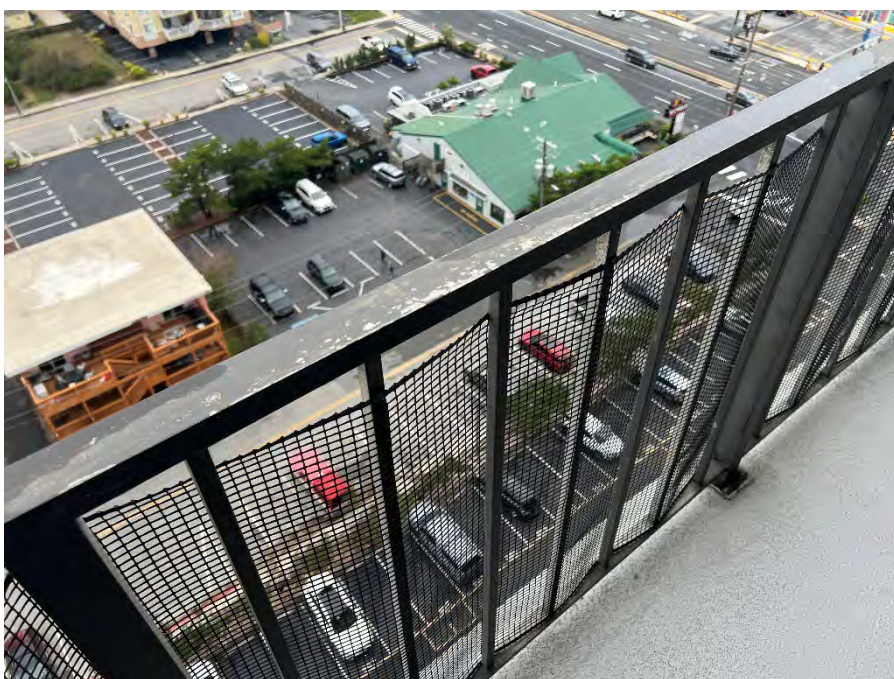
Photograph 10 – Debonded color-coat on balcony railing.

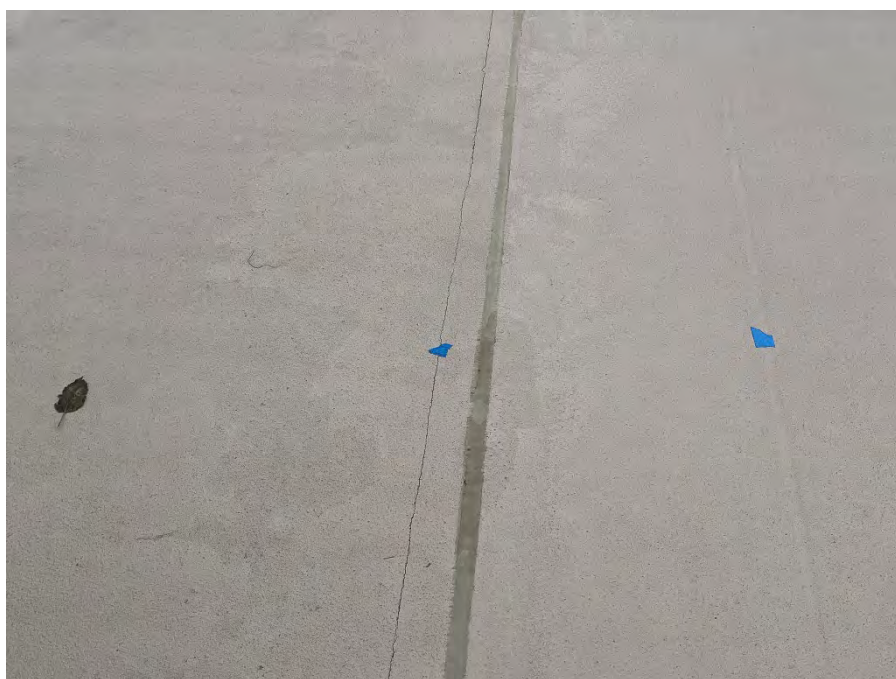
The swimming pool, sundeck, and related features (deck, equipment, etc.) ranged in condition from good to poor at the time of our inspections. Cracks were noted in the pool deck coating in numerous areas (see Photograph 12). Similar cracks were evident in the sundeck coating as well (see Photograph 13). Additionally, sealants in the sundeck control joints were split and debonded in a few instances (see Photograph 14). Calcium deposits were noted in the garage (see Photograph 15), possibly related to water intrusion through debonded sealants and cracks. Corrosion was observed on the gate push bar providing access from the swimming pool to the sundeck (see Photograph 16).

Photograph 12 – Crack in swimming pool deck coating.

The cracks and split/debonded sealants in the pool deck and terrace should be repaired. The loose handrail connection on the beach access stair assembly should be properly repaired. The swimming pool and associated elements should be inspected annually by a qualified contractor.

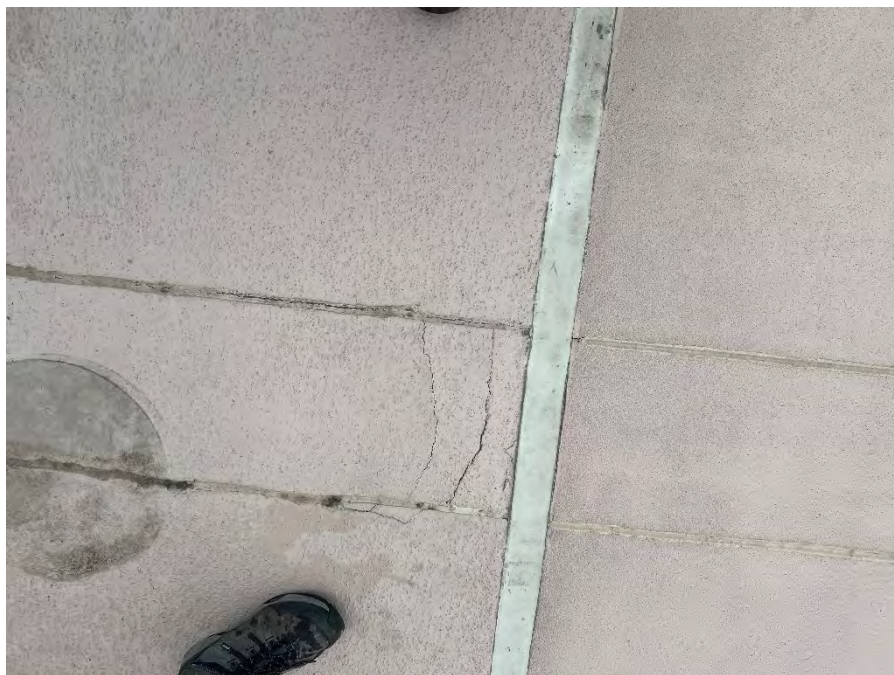
Photograph 13 – Cracks in terrace coating.

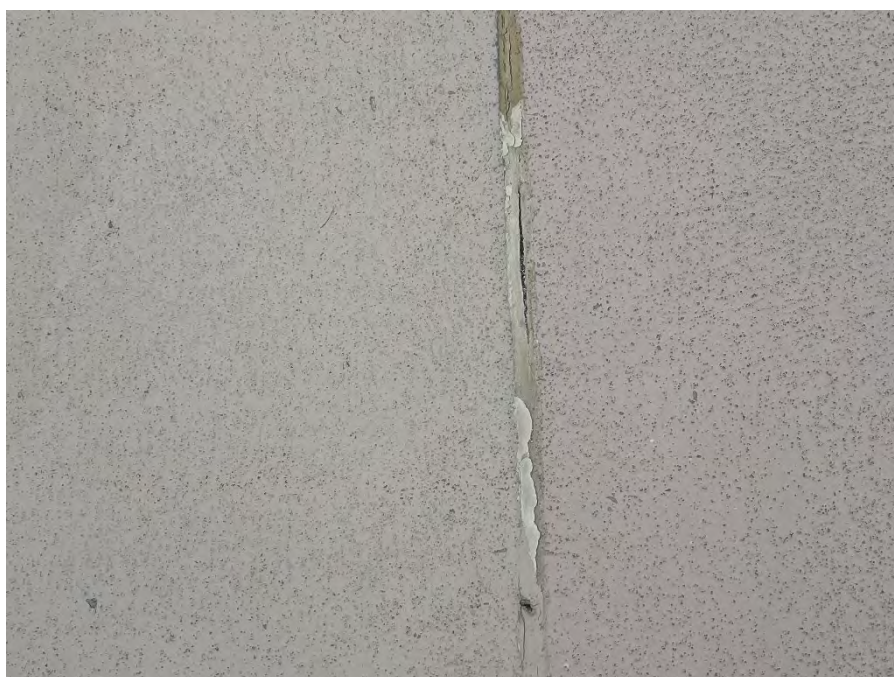
Photograph 14 – Debonded control joint sealant in terrace.

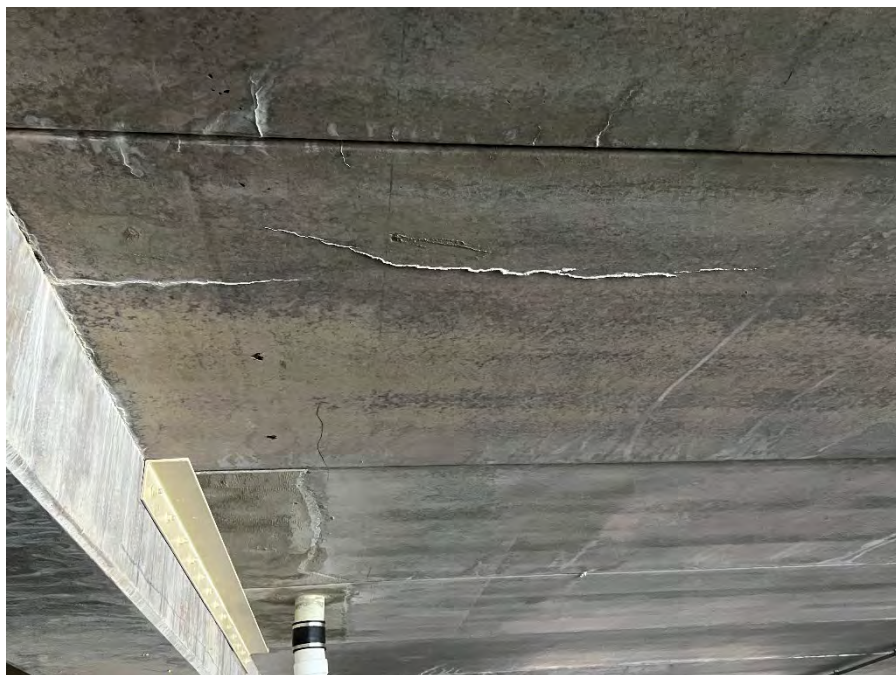
Photograph 15 – Calcium deposit in the soffit of the parking garage.

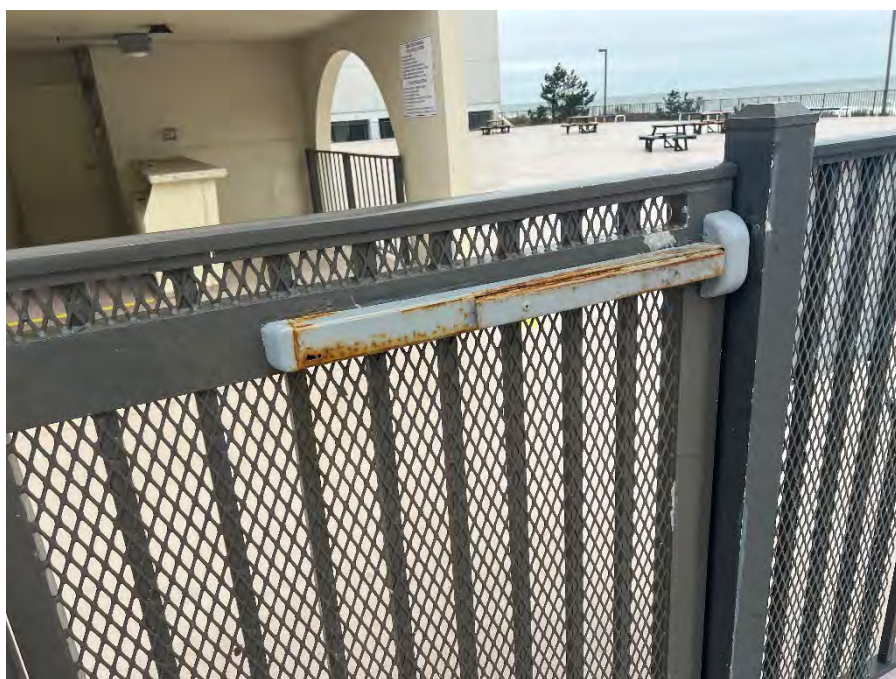
Photograph 16 – Corrosion on the gate push bar between the swimming pool and sundeck.

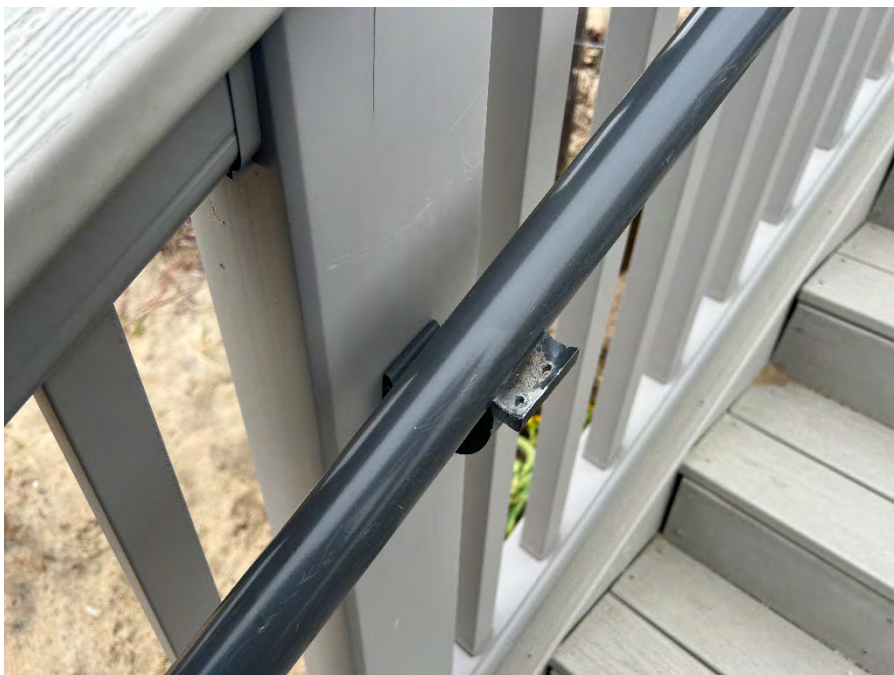
The stair and landing assembly appeared to be in good condition. The handrail was loose at one of the attachment points (see Photograph 17). Additionally, the color-coat on the handrail was debonded and missing in a few instances (see Photograph 18).

Photograph 17 – Loose handrail connection on stair assembly leading to the beach.

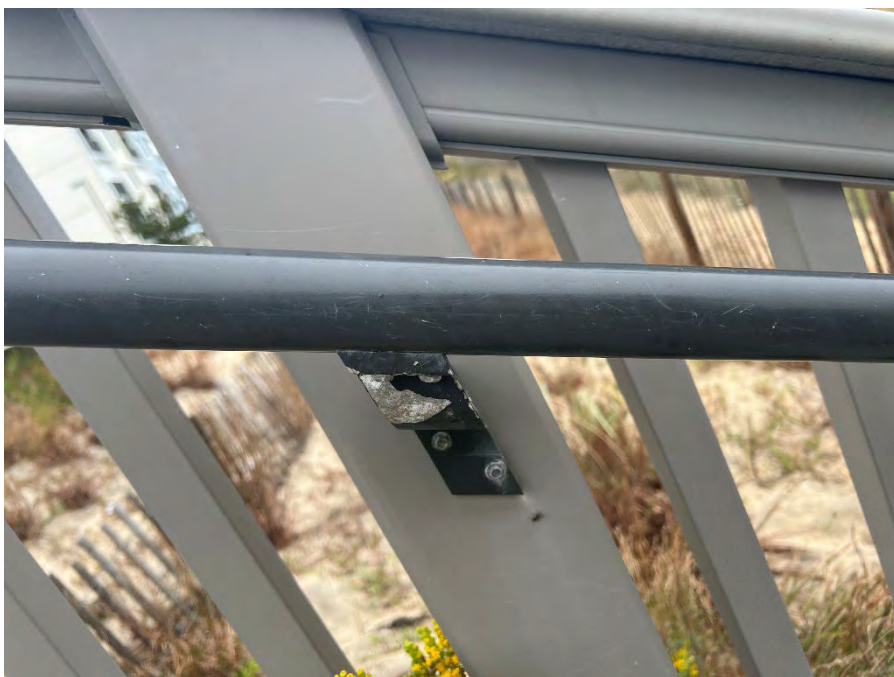
Photograph 18 – Debonded color-coat on stair assembly handrail leading to the beach.

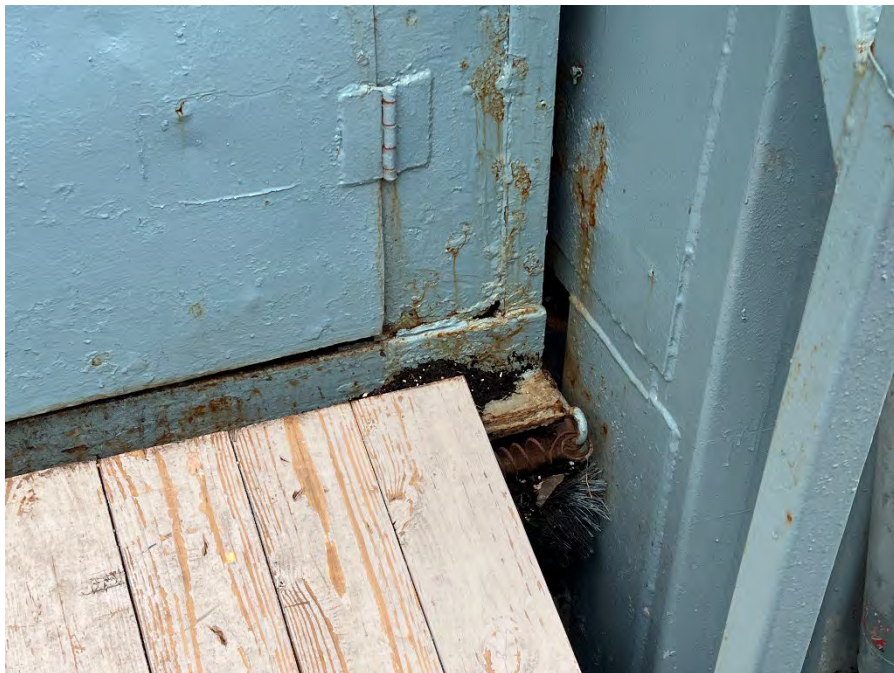
The trash compaction system, at the time of our inspection, appeared to be in fair condition. Some corrosion was noted on the compactor (see Photograph 19)

Photograph 19 – Corrosion on trash compactor.

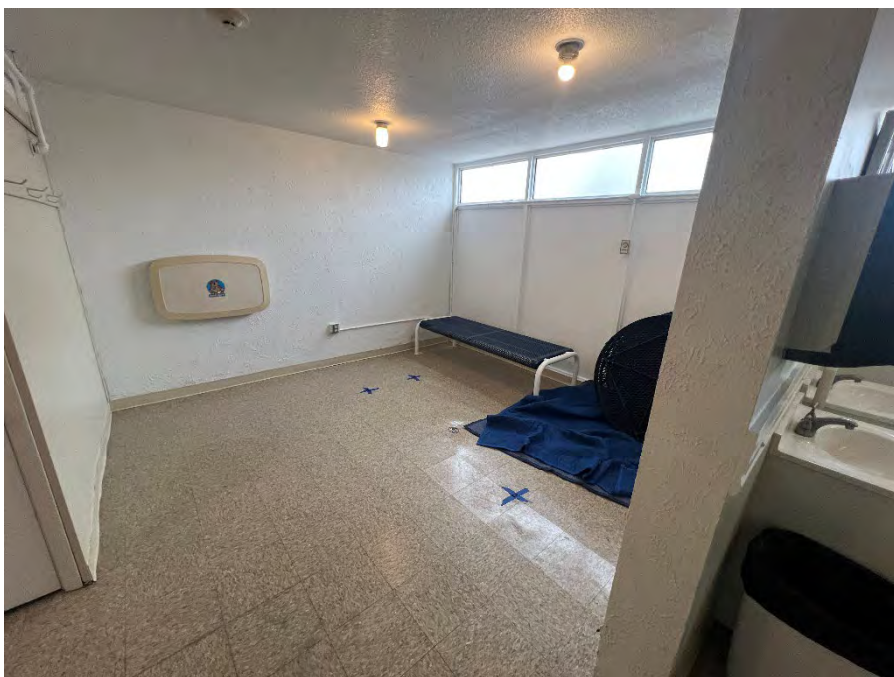
The interior finishes ranged from good to poor condition at the time of our inspection. Some of the tiles in the bathrooms were debonded (see Photograph 20). Several tiles had been replaced but were mismatched (see Photograph 21).

Photograph 20 – Debonded tile in the pool bathrooms.

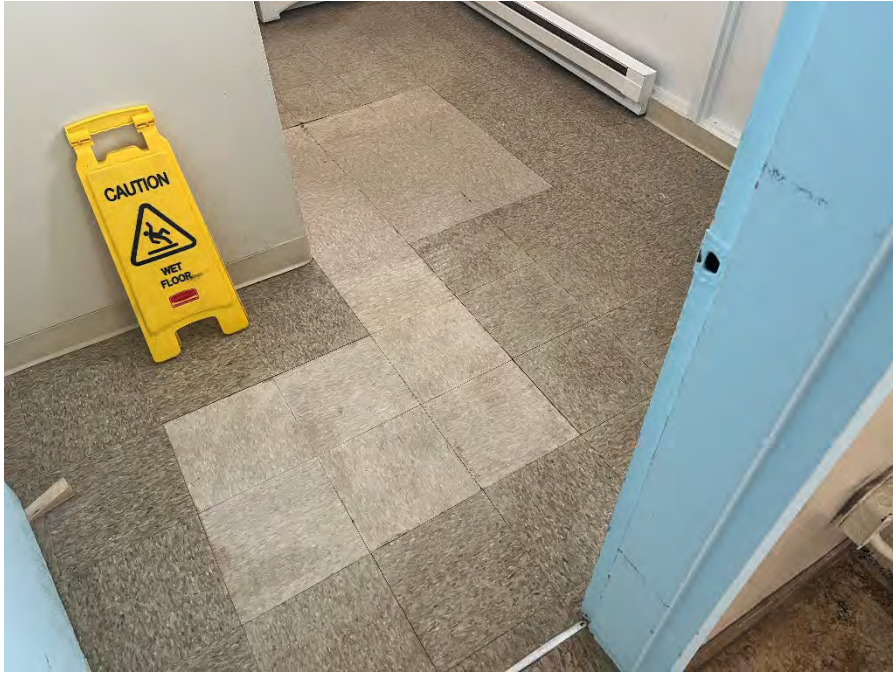
Photograph 21 – Mismatched tiles in the.

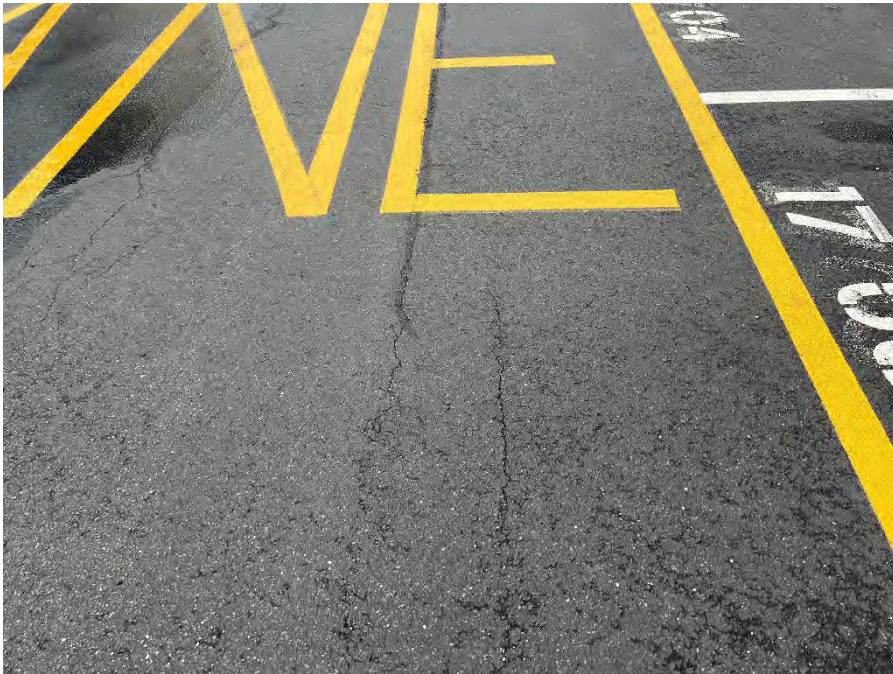
1. Cracks were present in the pavement in several areas (see Photograph 22). Most were single cracks; however, interconnected cracking was observed in some instances (see Photograph 23).
2. Ponded water was present on some areas of the pavement (see Photograph 24). This could pose a slip hazard during freezing temperatures.

Photograph 22 – Simple cracks in asphalt pavement.

The cracks in the pavement should be sealed. For asphalt pavement to achieve maximum life-cycle performance, it must be adequately maintained. Presented in Appendix D are some general guidelines for placing an asphalt overlay as well as general maintenance guidelines.

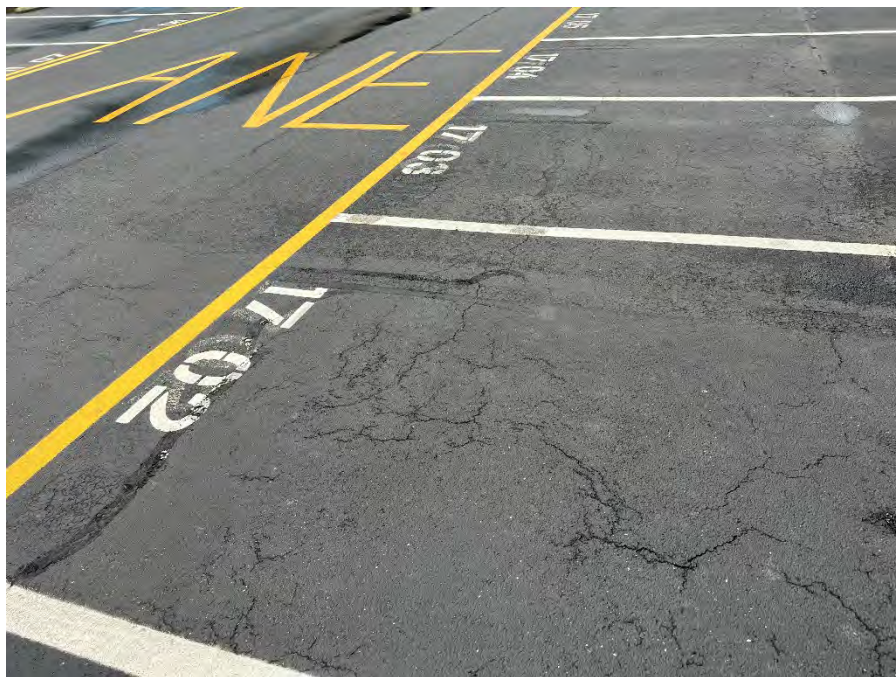
Photograph 23 – Interconnected cracks in asphalt pavement.

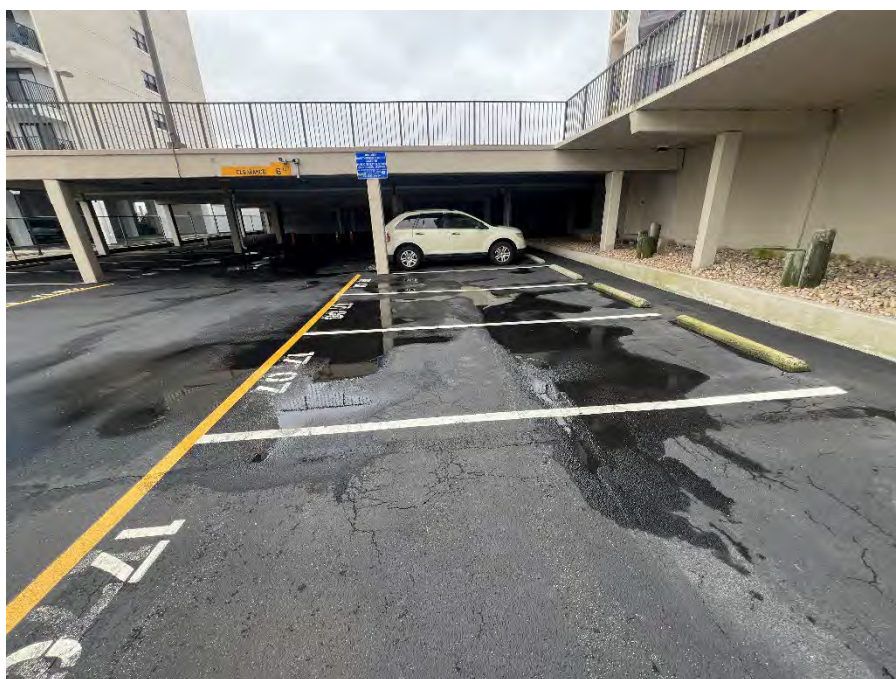
Photograph 24 – Ponded water on asphalt pavement.

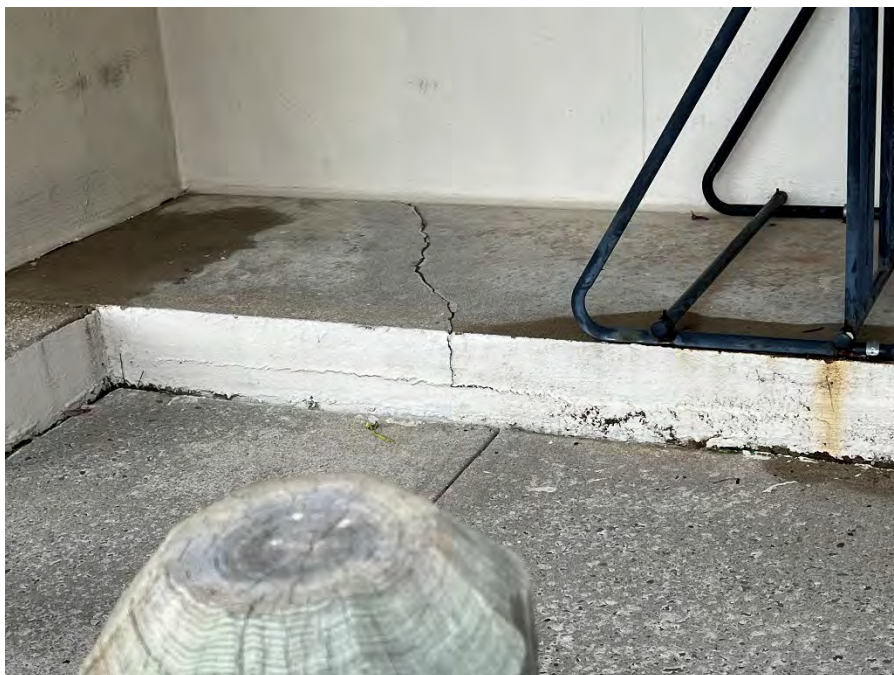
The concrete site elements appeared to be in fair condition overall. Cracks were noted in the raised concrete walkways and trash enclosure apron (see Photographs 25 and 26).

Photograph 25 – Crack in raised concrete walkway.

The concrete sidewalk should be inspected at least twice a year for cracks, spalled surfaces, displacement, evidence of substrate erosion (voids), and other defects. Seriously distressed areas should be mapped and clearly marked (for repairs).

Correction of the most obvious (and potentially hazardous) conditions should be deemed imperative. Cracks, settlement, or other defects that result in a height disparity of one-half (1/2) inch or more present potential tripping hazards. These conditions indicate severe damage that should be repaired appropriately. Surface treatments, patching, and other expedient methods are not recommended, as they generally prove ineffective in the long term. Therefore, the entire damaged concrete section should be replaced.

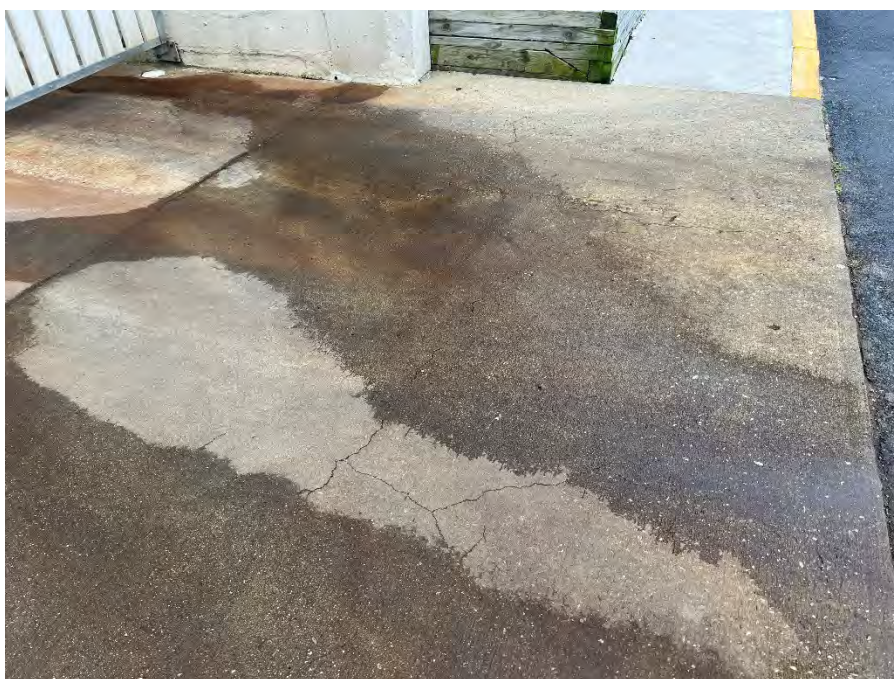
Photograph 26 – Cracks in trash enclosure concrete apron.
