SUBJECT: Report of Replacement Reserve Study  
9400 Condominium  
Ocean City, Maryland  
ETC Project: M5-5283

**APPENDIX A  
PHOTOGRAPHS  
9400 CONDOMINIUM  
OCEAN CITY, MARYLAND  
ETC PROJECT M5-5283**

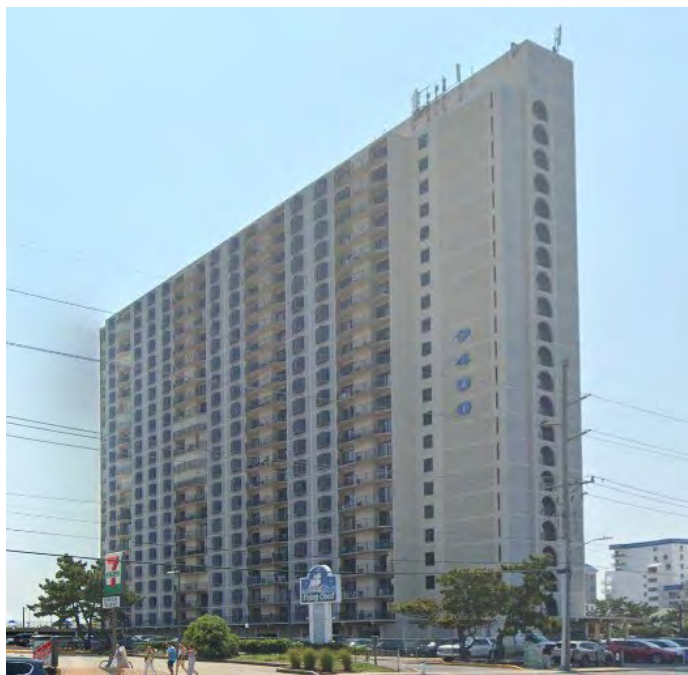
The building is faced with concrete panels coated with an elastomeric finish (see Photographs 3 and 4). Color-coated aluminum windows and doors are situated in building openings. Steel doors are utilized to access the utility rooms.

Photograph 3 – North elevation of the building.

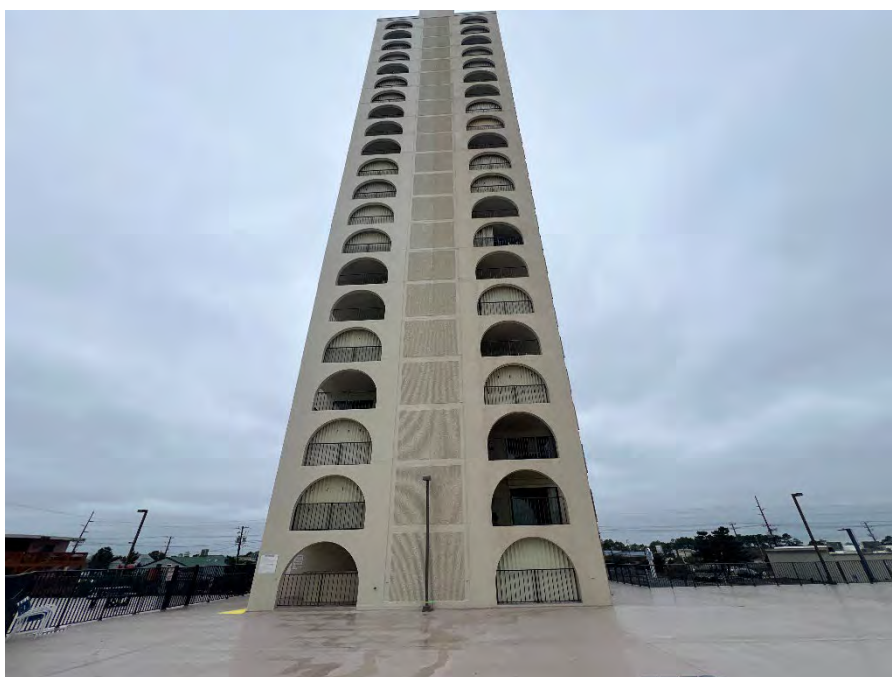
Photograph 4 – East elevation of the building.

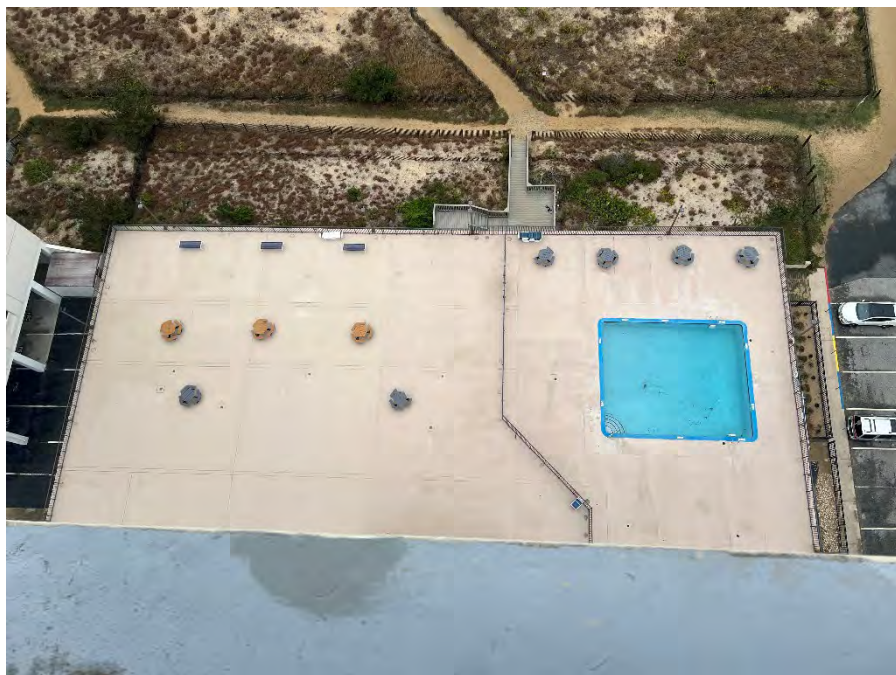
The outdoor swimming pool is located at the northeast corner of the property (see Photograph 11). The equipment consists of a sand filter system and various pumps. The pool equipment is housed in a room beneath the pool. The swimming pool deck consists of a raised concrete structure coated with an elastomeric pedestrian coating. Sundecks (terraces) of similar construction extend along the rear and sides of the building. Metal picket-style railings delineate the decks and provide fall protection. A landing and stair assembly, constructed of pressure-treated wood and composite decking, extends from the sundeck and provides access to the beach. Composite railings with aluminum handrails delineate the assembly.

Photograph 11 – Outdoor swimming pool and sundeck.

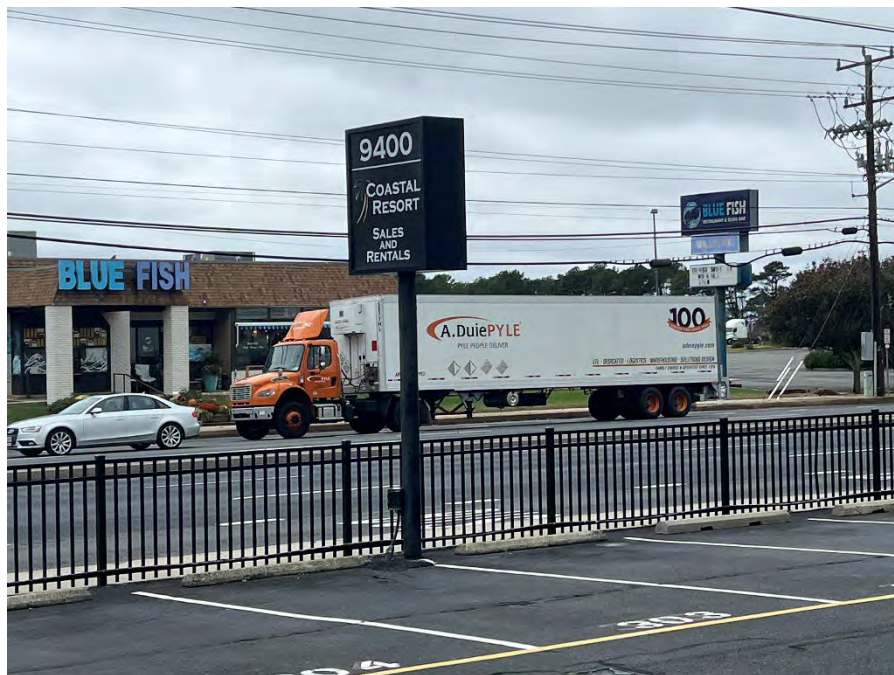
A pole-mounted metal sign delineates the property's entrance on Coastal Highway (see Photograph 27).

Photograph 27 – Entrance sign.
